UNDERWATER BRIDGE INSPECTION REPORT

STRUCTURE NO. 69580
CSAH NO. 31
OVER THE
ST. LOUIS RIVER
DISTRICT 1 - ST. LOUIS COUNTY

PREPARED FOR THE
MINNESOTA DEPARTMENT OF TRANSPORTATION
BY
COLLINS ENGINEERS, INC.
JOB NO. 5221 (CEI 1)

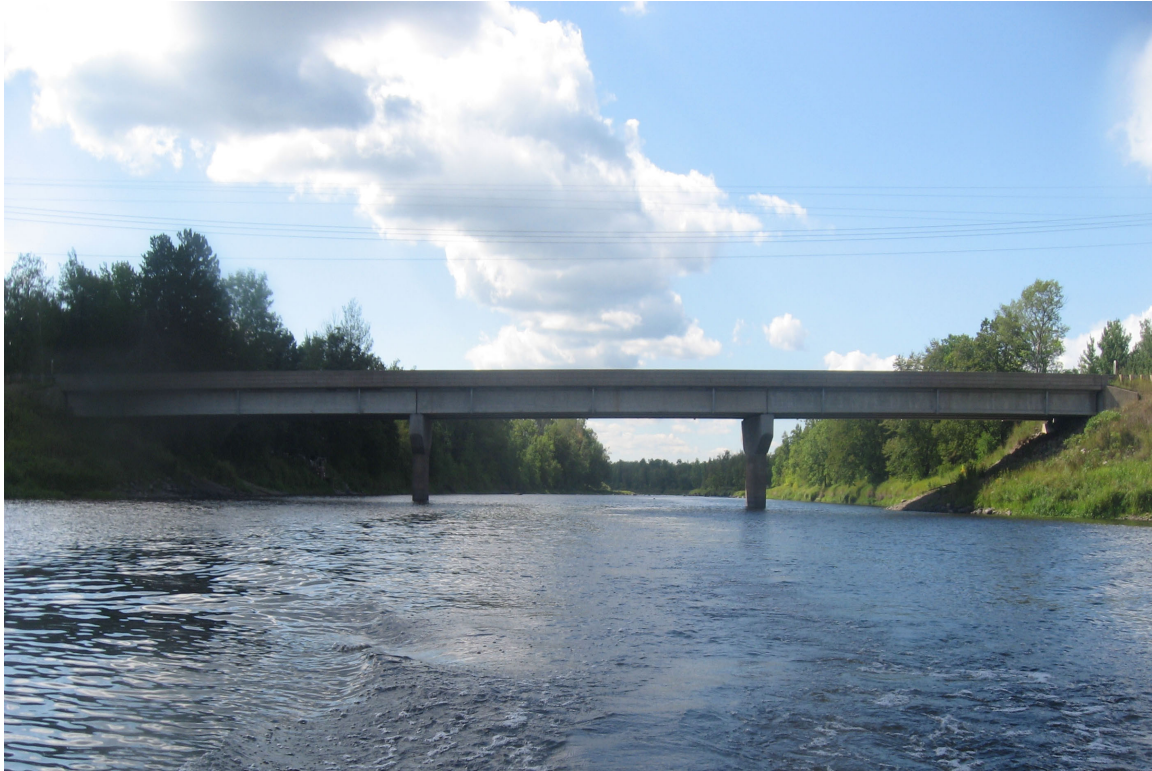
Photograph 1. View of Structure, Looking West.

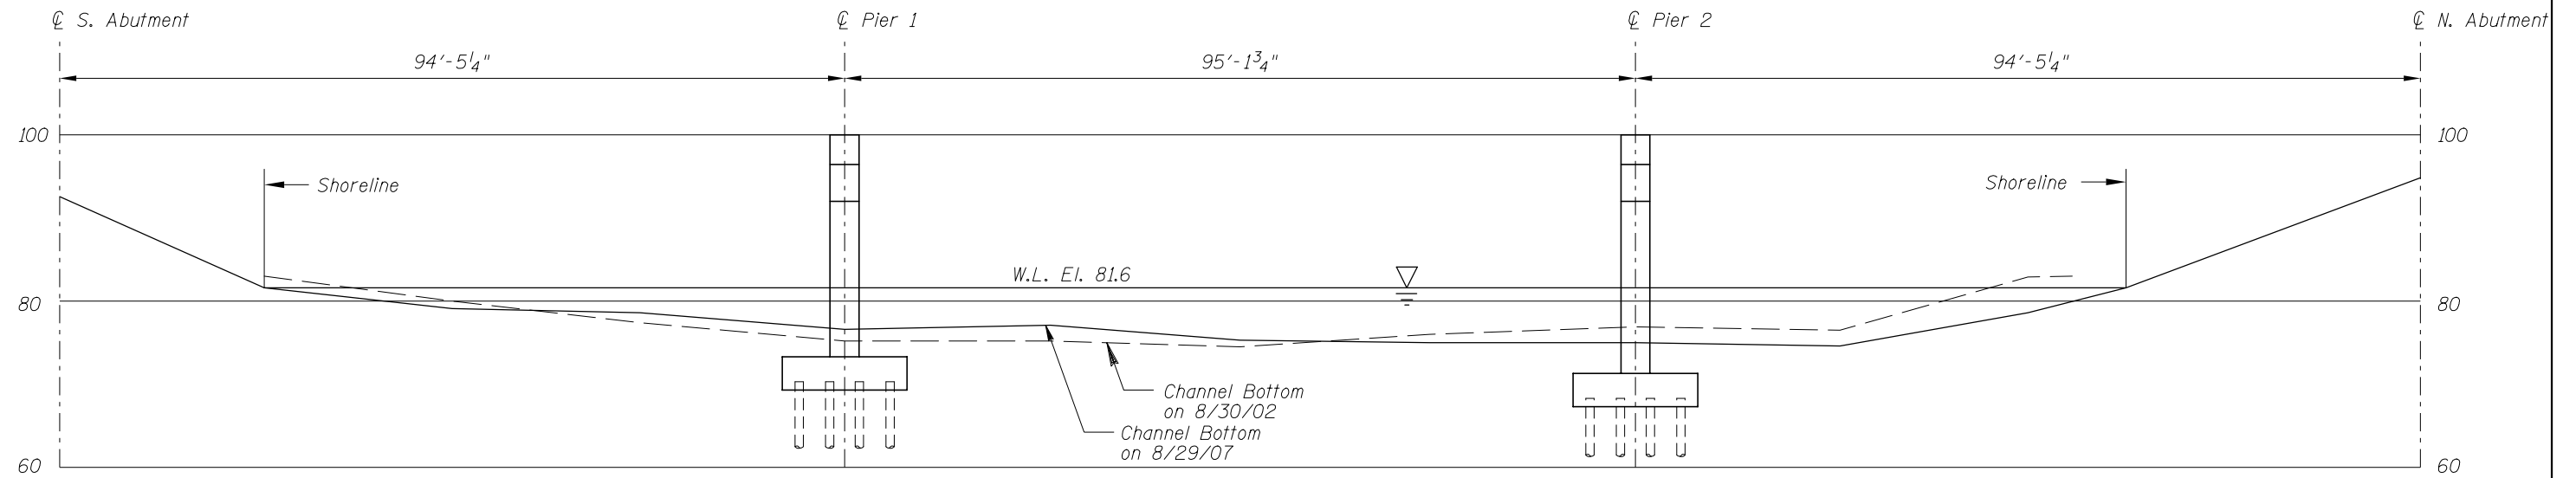
UPSTREAM FASCIA PROFILE

- The channel bottom material consisted of 1-foot-diameter and smaller riprap and cobbles with no probe rod penetration.
- The concrete at both piers exhibited light scaling from 3 to 4 feet above the waterline to the channel bottom with a typical penetration of 1/8 inch and maximum penetration of 1/4 inch.
